DEPARTMENT OF TRANSPORTATION  
Structure Maintenance & Investigations

Bridge Number : 02C0016  
Facility Carried: SALMON RIVER ROAD  
Location : 13.2 MI W/O SAWYERS BAR  
City :  
Inspection Date : 08/15/2017 ✓ sw ✓  
Inspection Type  
Routine  FC Underwater Special Other

Bridge Inspection Report

STRUCTURE NAME: SALMON RIVER

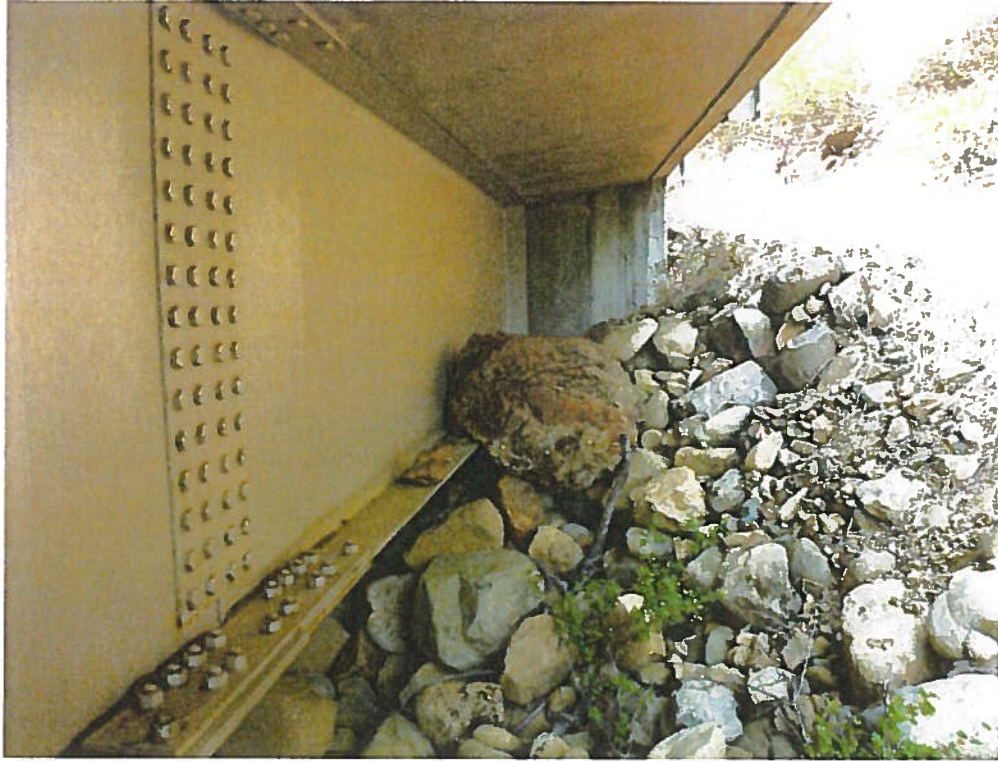
Photo No. 1

(107)									
There is a boulder, approximately 3 feet in diameter, bearing on Girder 1 near Abutment 1 (Photo 1).									
04/26/2016 FCI: No fractures or cracks were found.									
(107-1000)									
There are random areas of surface corrosion along the bottom flanges typically adjacent to the deck drains.									
(107-515-3440)									
Refer to element defect 107-1000.									
205		Column-RC		2	3	each	2	0	0 1
1090		Exposed Rebar (PS Conc./RC)		2	1		0	0	0 1
(205-1090)									
The upstream nose of the Pier 3 column is covered with a corrugated metal shell and was not visible for inspection. Previous bridge inspection reports indicate the full circumference of the column was covered with a corrugated metal wrap prior to the 05/20/1981 routine inspection. A portion of the corrugated metal wrap along the downstream nose was somehow removed prior to the current investigation.									
There is abrasion, up to 2 inches deep, extending vertically approximately 2 to 10 feet from the channel bottom along the downstream nose of the Pier 3 column. The total visible abraded area is approximately 25 square feet. There is approximately 20 exposed vertical reinforcing bars and several fractured stirrup reinforcing. The abraded area also exposes a portion of a lap splice for the primary reinforcement (Photo 2). Exposed reinforcing in the Pier 3 column was first documented in the 11/04/1971 routine inspection report.

Boulder bearing on Girder 1 near Abutment 1.

RecDate: 09/18/2013      EstCost:      Remove the boulder bearing on the Girder  
Action : Bridge-Misc      StrTarget: 1 YEAR      1 flange near Abutment 1.  
Work By: LOCAL AGENCY      DistTarget:  
Status : PROPOSED      EA:

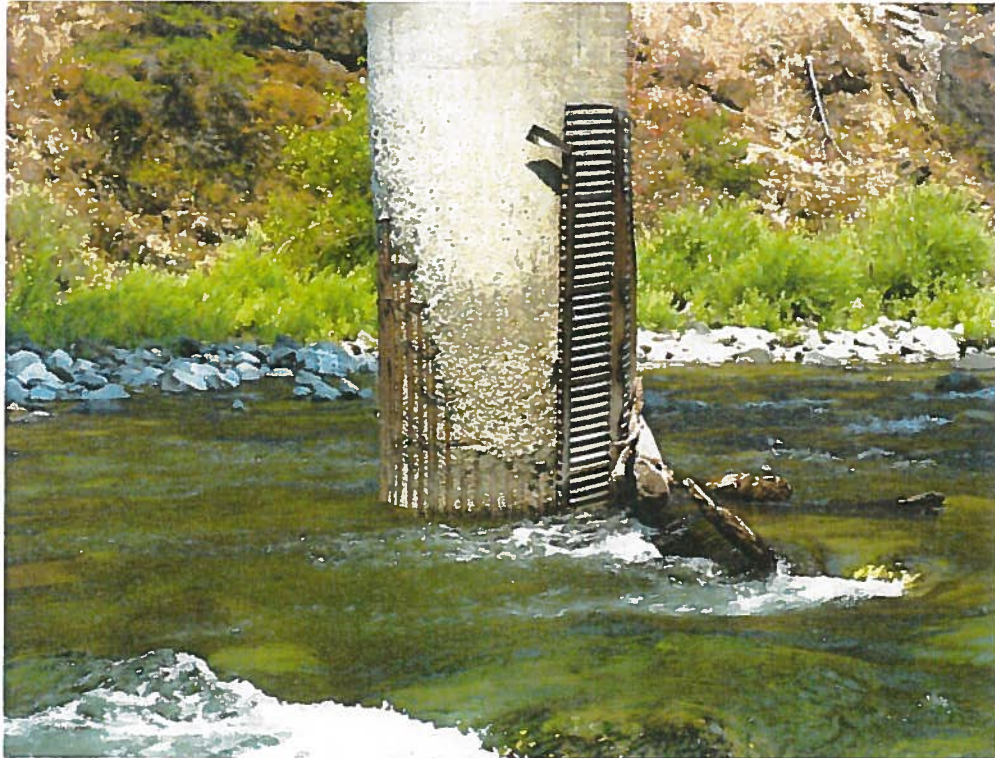
Photo No. 2

Pier 3 column distress.

Rehab the Pier 3 column around the distressed area. Continued concrete abrasion and corrosion of the exposed reinforcing from streamflow will further deteriorate the distressed area. Refer to element defect 205-1090 for information on the Pier 3 column distress.

RecDate: 09/06/2015      EstCost:      Rehab the distressed area in the Pier 3  
Action : Sub-Patch spalls      StrTarget: 2 YEARS      column.  
Work By: LOCAL AGENCY      DistTarget:  
Status : PROPOSED      EA:
